## TCV mirrors cleaned by plasma

Metallic mirrors exposed in TCV tokamak were cleaned by plasma in laboratory. A gold (Au) mirror was deposited with 185–285 nm of amorphous carbon (aC:D) film coming from the carbon tiles of TCV. Another molybdenum (Mo) mirror had a thicker deposit due to a different location within the tokamak. The thickness measurements were carried out using ellipsometry and the reflectivity measurements performed by spectrophotometry revealed a decrease of the specular reflectivity in the entire range (250–2500 nm) for the Mo mirror and specifically in the visible spectrum for the Au. Comparison of the simulated reflectivity using a refractive index of 1.5 and a Cauchy model for the aC:D gives good confidence on the estimated film thickness. Plasma cleaning using radio frequency directly applied to a metallic plate where the mirrors were fixed demonstrated the ability to remove the carbon deposits. A mixture of 50% hydrogen and 50% helium was used with a –200 V self-bias. Due to the low sputtering yield of He and the low chemical erosion of hydrogen leading to volatile molecules, 20 h of cleaning were needed for Au mirror and more than 60 h for Mo mirror. Recov

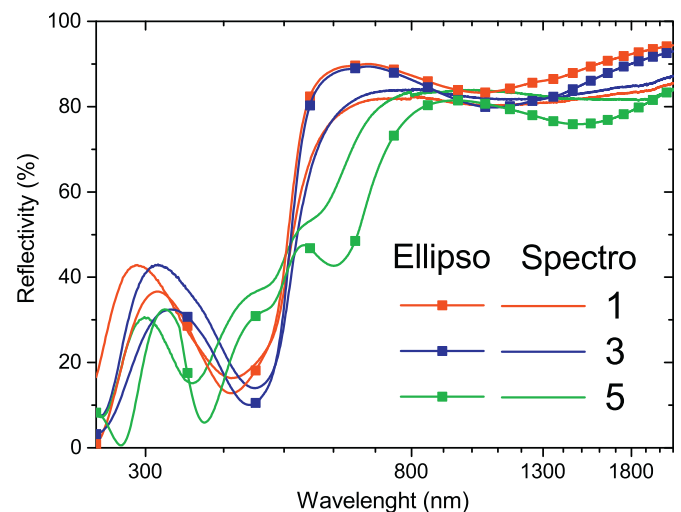
**Fig. 2.** Calculated reflectivity using the Cauchy model and the reflectivity measured using a spectrophotometer for the Au mirror, at the positions displayed in Fig. 1b). The X axis is on a log scale.

deposited layer was mainly composed of carbon and deuterium. Chemical analyses of the surface using X-Ray Photoelectron Spectroscopy (not shown here) revealed only carbon and oxygen. The optical properties (refractive index  $n$  and extinction coefficient  $k$ ) of a-C:D film can be accurately described with a Cauchy relation where  $n_i$ , and  $k_i$  are fitting parameters [11]. The films are considered as homogeneously deposited on a semi-infinite substrate, and the roughness of both the film and the substrate are neglected. Film thickness was calculated and displayed in Fig. 1b), 100 nm thickness difference is measured along the position to the plasma, and vertically no change appeared. The  $n$  (at 632.5 nm) varied from 1.48 to 1.56 for all points and  $k$  was calculated to be zero. This revealed a soft hydrocarbon film typical for mirrors exposed in TCV [12] and resembled T-10 tokamak (Kurchatov Institute) cleaning discharge films on mirrors [13]. The reflectivity calculated using the model: air, our Cauchy film, SiO film (10 nm) and an Au layer using the Palik constant is plotted in Fig. 2. In the same figure, the

reflectivity measured with the spectrophotometer for the same position is also plotted. The relatively good agreement between both methods validates our model with the calculated film thickness.

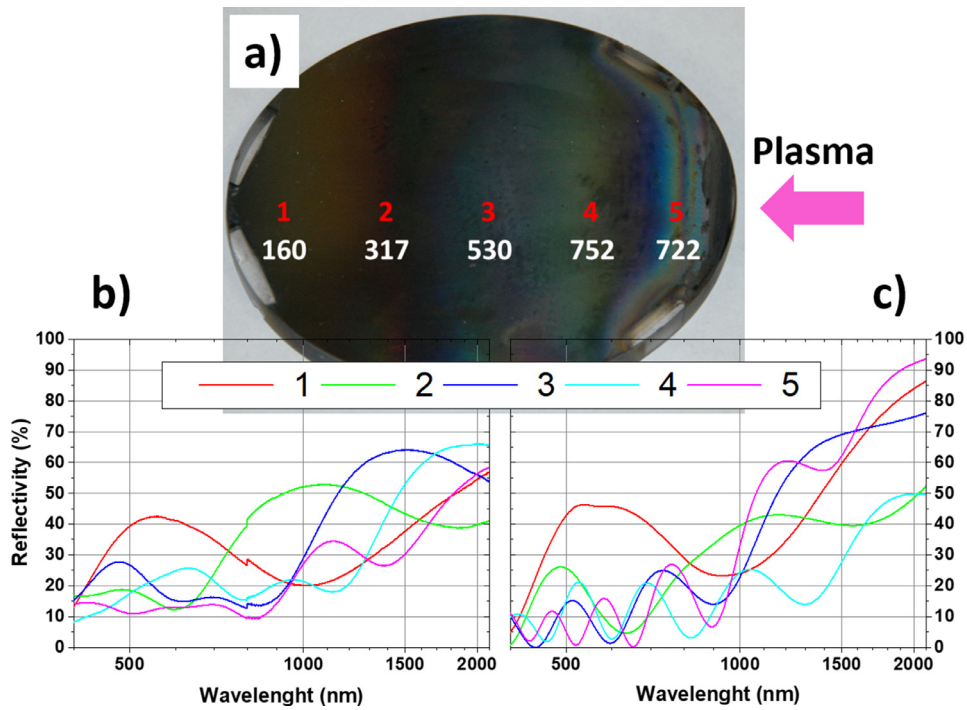
**Fig. 5.** a) Mo mirror after TCV exposure: the measurements positions on this mirror are in red and the film thickness calculated by ellipsometry is below, b) reflectivity measured by spectrophotometry and c) calculated by ellipsometry. (For interpretation of the references to colour in this figure legend, the reader is referred to the web version of this article.)

The Mo mirror was also measured in the same way: a higher thickness gradient ( $> 560$  nm) between the closest position to the plasma and the back of the mirror was calculated (Fig. 5a). The thicker carbon film can be explained by the longer exposure time in TCV and also the position with respect to the plasma. The reflectivity measured by the spectrophotometer and the one calculated by the Cauchy model as previously explained are not entirely the same especially in the near infrared region (Fig. 5). Optical images after TCV exposure do not show the electrical treeing phenomena observed in Fig. 3.

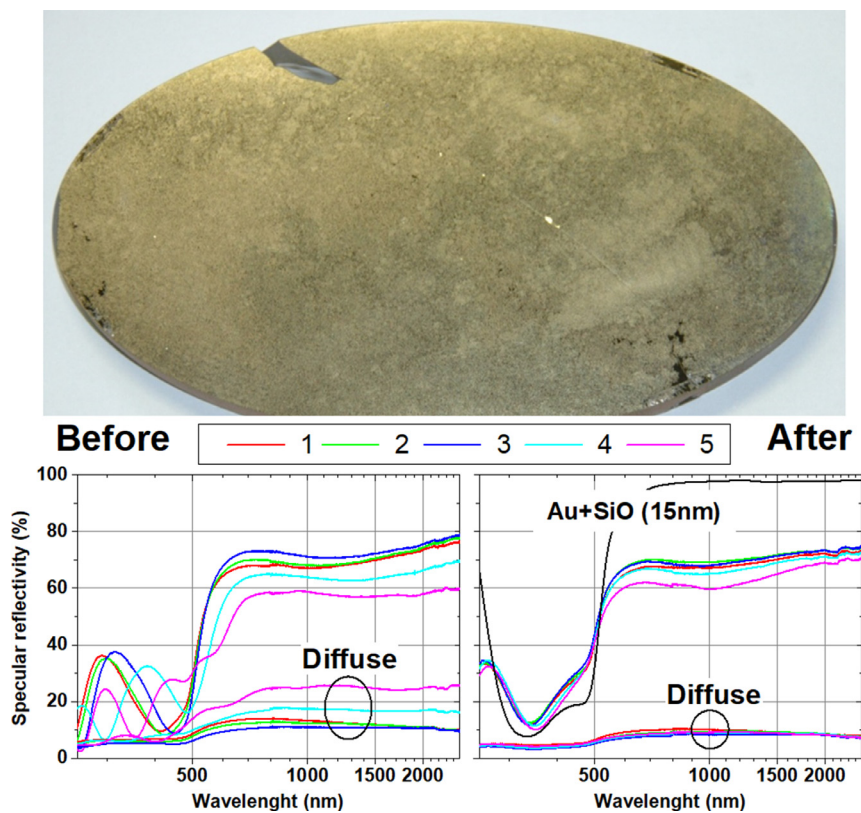
**Fig. 6.** Optical image of the Au mirror after plasma cleaning. Specular and diffuse reflectivity of the Au mirror measured before and after plasma cleaning. Au reflectivity using Palik optical constant is plotted as reference.

A 20 h plasma cleaning was performed on the Au mirror using a H<sub>2</sub>/He gas mixture for a self-bias of –200 V. The specular reflectivity (total minus diffuse) is plotted in Fig. 6 before and after cleaning. No measurement of the pristine Au mirror is available so in Fig. 6 (After) is displayed the reflectivity of Au with 15 nm SiO calculated using the optical constant of both materials. Even though the reflectivity after cleaning is lower than the reference, the strong absorption at 350 nm is reproduced by the calculated reflectivity. An important point is the diffuse reflectivity after cleaning which is 10% higher as plotted in Fig. 6 and gives this visual milky aspect after cleaning (Fig. 6). After TCV exposure the diffuse reflectivity was higher than 25% in the range 800–2500 nm (Fig. 6). After plasma cleaning, SEM or optical images (not shown here) revealed the same unchanged pattern. Removal of the carbon film by plasma cleaning did not change this phenomenon resulting in an always high diffuse reflectivity.

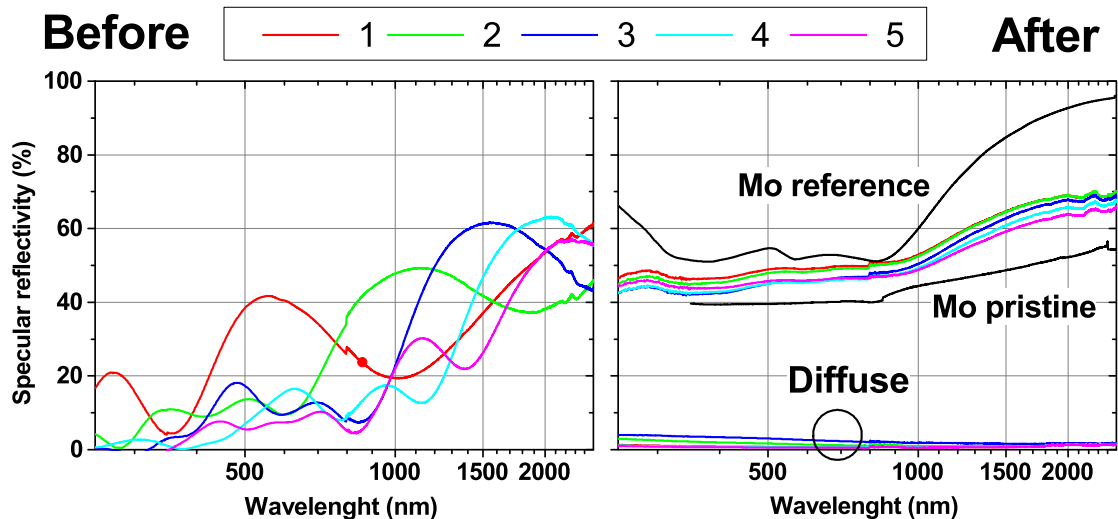
Fig. 8. Specular reflectivity of the Mo mirror measured before and after plasma cleaning. Mo reflectivity using Palik optical constant as well as the measured Mo pristine from the manufacturer are plotted as references.
