In situ cleaning of diagnostic first mirrors: an experimental comparison between plasma and laser cleaning in ITER-relevant conditions

To cite this article: A. Maffini *et al* 2017 *Nucl. Fusion* **57** 046014

A. Maffini¹, L. Moser², L. Marot², R. Steiner², D. Dellasega^{1,3}, A. Uccello³, E. Meyer² and M. Passoni^{1,3}

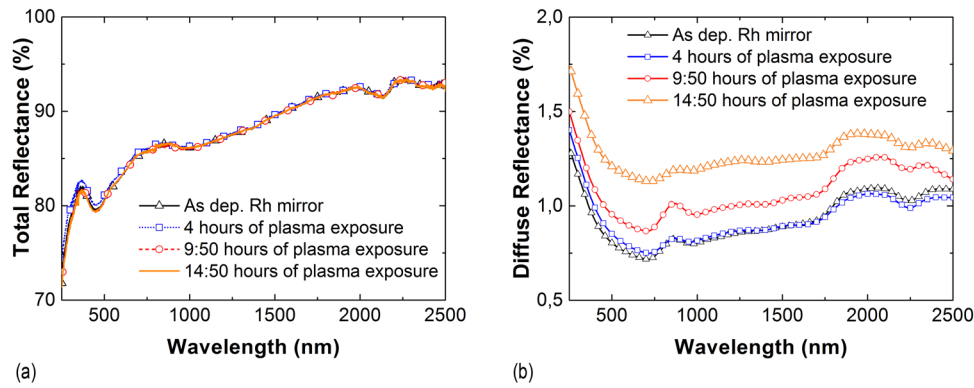
Figure 3. (a) R_{tot} of a Rh mirror before plasma exposure (black triangles), after 4 h of plasma treatment (blue squares), after 9.5 h of plasma treatment (red circles), and after 14.5 h of plasma treatment (solid orange). (b) R_{diff} of a Rh mirror before plasma exposure (black triangles), after 4 h of plasma treatment (blue squares), after 9.5 h of plasma treatment (red circles), and after 14.5 h of plasma treatment (solid orange).

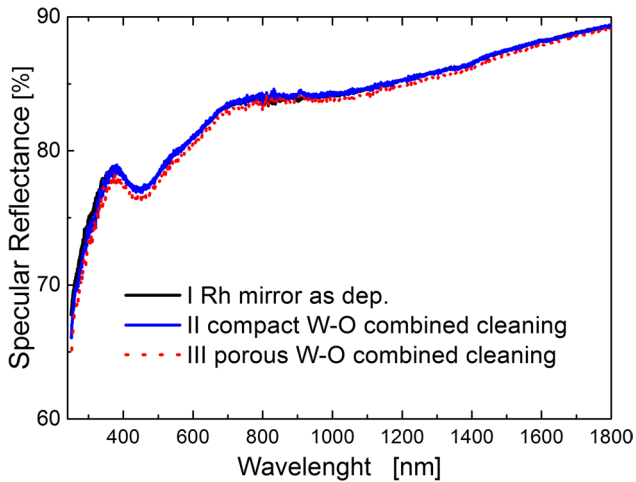
Figure 17. R_{spec} of a Rh mirror before contamination (I, black); contaminated with compact W/O after 2 laser cleaning scans and 45 min of plasma cleaning (II, blue); contaminated with porous W/O after 4 laser cleaning scans and 45 min of plasma cleaning (III, red).

The feasibility of this solution was tested on the mirrors that were previously contaminated with compact and porous W/O and laser cleaned as described in section 3. The mirrors were subsequently exposed for 45 min each to the same plasma conditions described in section 4. For both samples, the XPS analysis performed after the final plasma cleaning session detected only Rh and O, indicating a complete removal of contaminants. The resulting specular reflectance is coincident with the pristine value, as can be appreciated in figure 17. In particular, the combined cleaning approach ensured a complete recovery of the mirror properties also in the UV region (where laser cleaning alone was not sufficient, see blue lines in figures 11(a) and (b)) and for porous contamination (very hard to treat by plasma cleaning alone). Furthermore, the time required for the combined cleaning is reduced by a factor of
